Report on the investigation of
the grounding of the sail training vessel

TS Royalist

5 April 2009

Report No 26/2009
December 2009

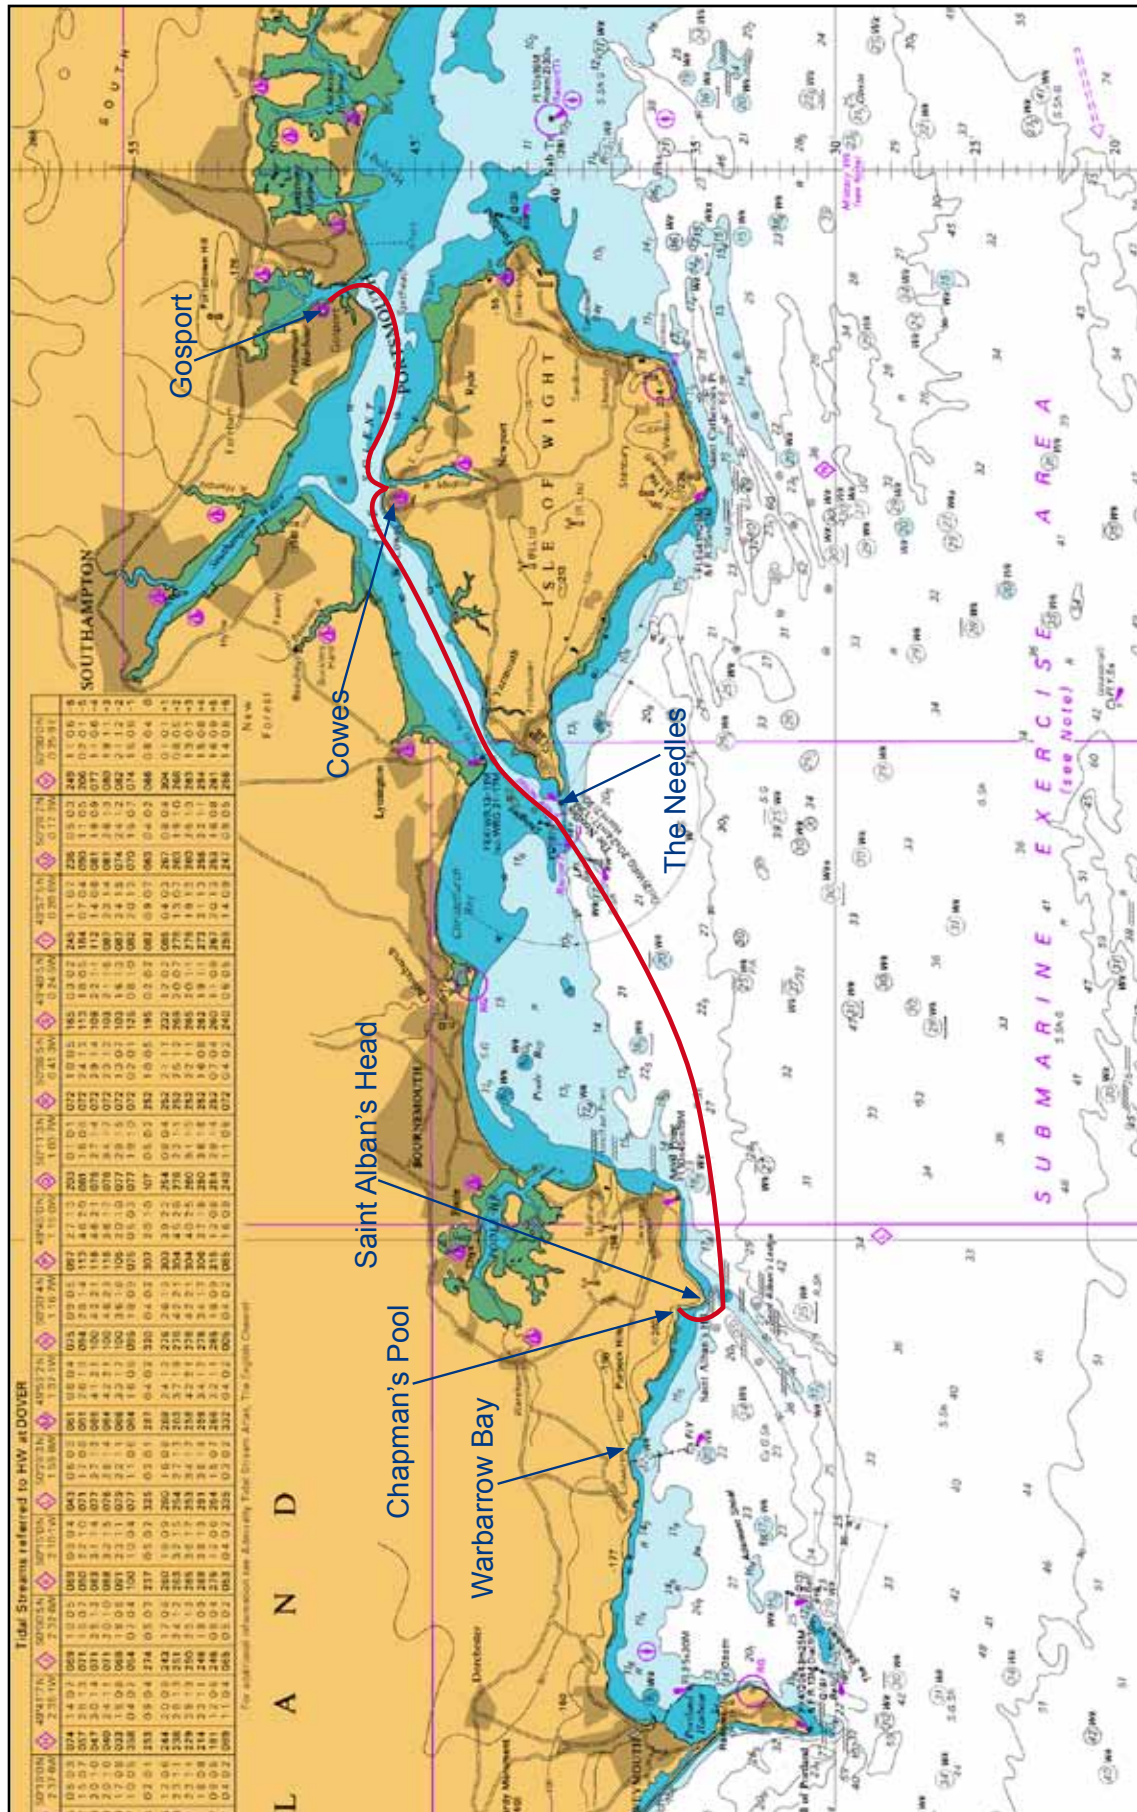
Figure 2

The master had decided that, because the vessel was making good time, he would visit Chapman's Pool (**Figure 2**) before resuming passage to Worbarrow Bay, where he intended to anchor for lunch. At this time, the trainee engineer was at the helm. The master used the echo sounder and one of the radar's variable range rings to keep a minimum distance off the land as the vessel rounded St Alban's Head. He then took the helm and steered a northerly course towards Chapman's Pool.
